# 2015 Indian River Lagoon Seagrass Mapping Final Project Report

Project # 28172

Report Date: May 19, 2016

Dewberry  
1000 N Ashley Drive, Suite 801  
Tampa, FL 33602  
Tel: 813-421-8635  
POC: Keith Patterson, PSM

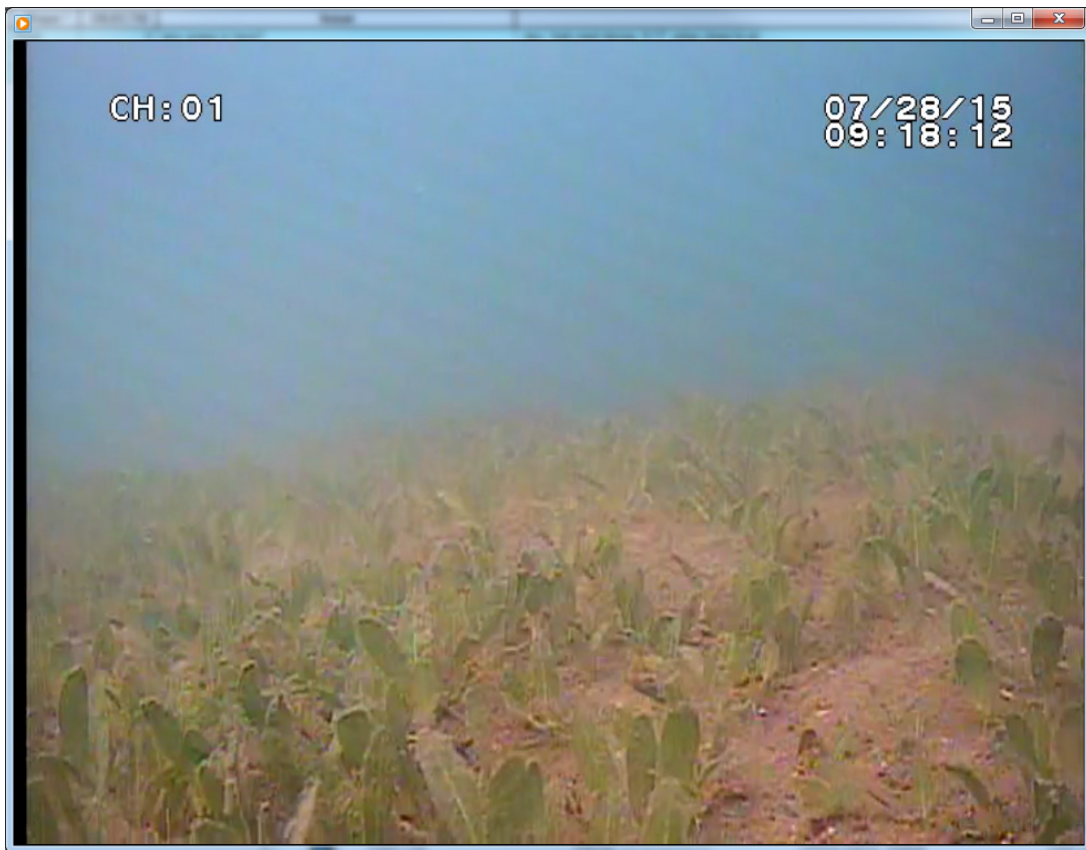
Figure 3 – Field work underwater video of seagrass bed

A significant amount of field work was accomplished for the project. A total of 679 field points were collected and documentation included 475 underwater video segments. Figure 3 is an example of the video clip with date and time stamp that is recorded in the field point attribute table.

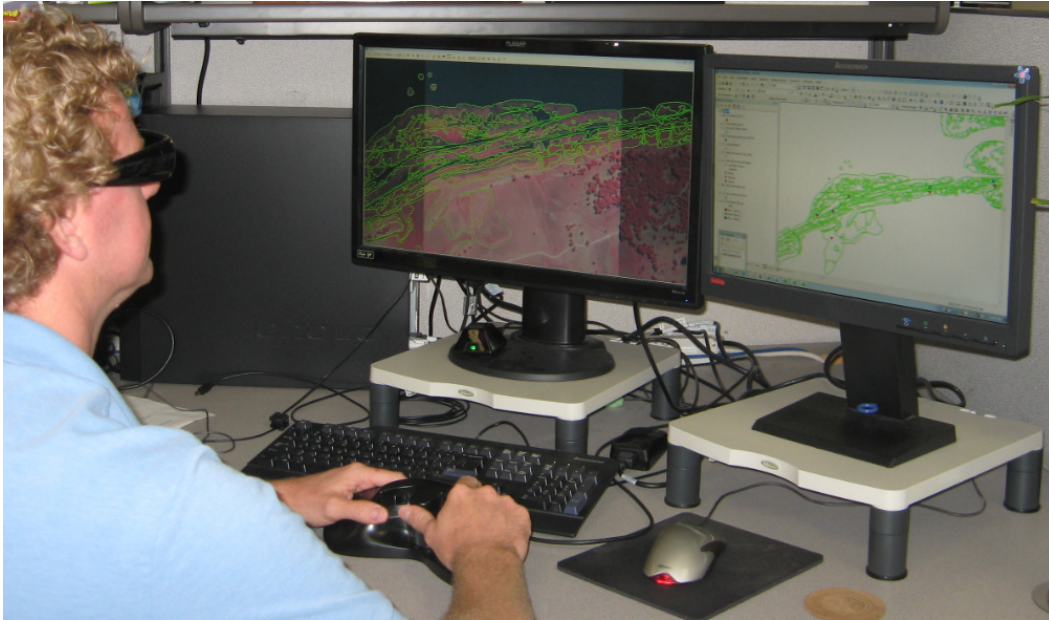
Figure 4- SOCET Stereo Workstation

Seagrass mapping for the Indian River Lagoon Project was accomplished using stereo photo interpretation. Interpretation was accomplished using Dewberry's SOCET SET and SOCET GXP softcopy photogrammetry workstations interfaced with SOCET for ArcGIS software. This software allows photo interpreted data to be stored within the ArcGIS software environment. Using SOCET SET/GXP, Dewberry was able to capture the data using stereo imagery which allowed the photointerpreters to see texture and depth. Seeing depth is beneficial in helping to identify pockets in the substrate where drift algae may accumulate. Figure 4 shows the stereo workstation.

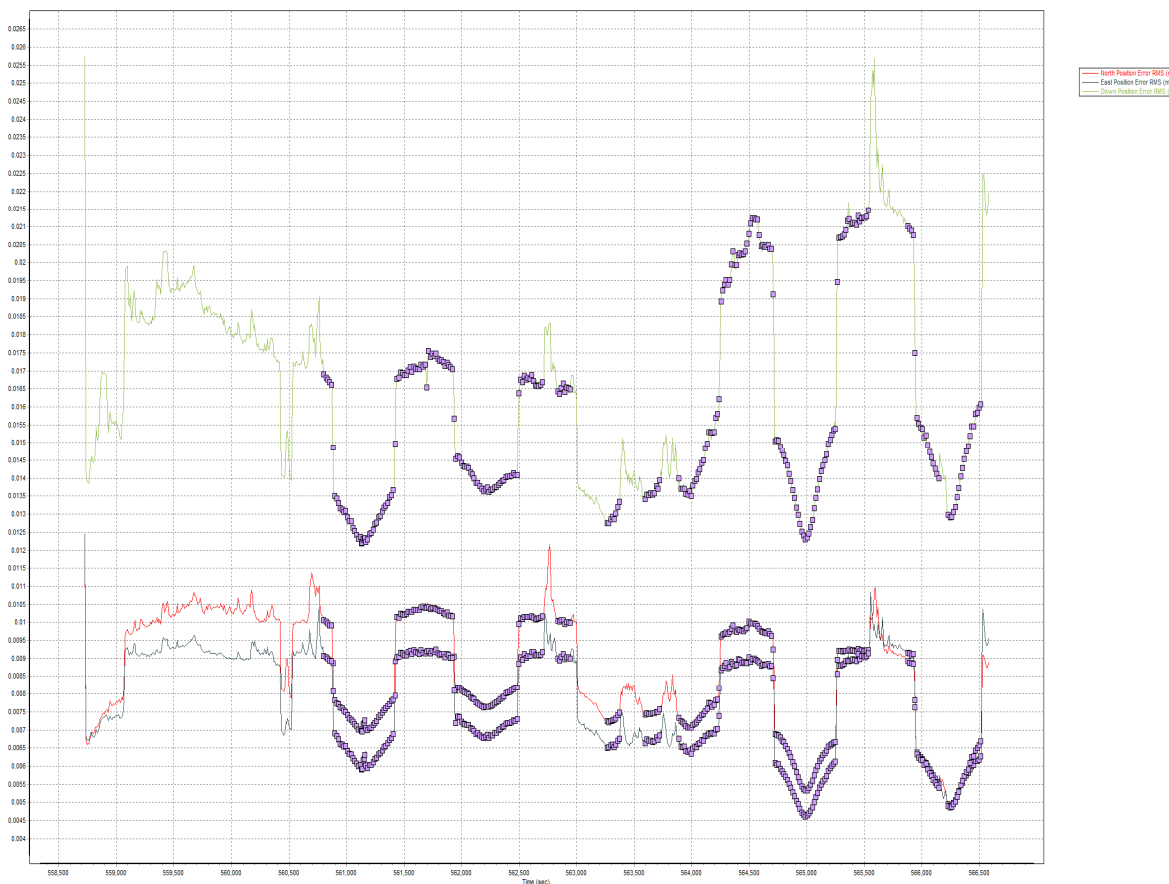
Figure 5 AGPS Sensor Errors

Continuously Operating Reference Stations (CORS) were used as control during acquisition. Figure 5 shows a graph that provides the typical ABGPS sensor errors and position residuals for the flight missions. Maximum deviation is within 10cm which was well within the acceptable range for the project.

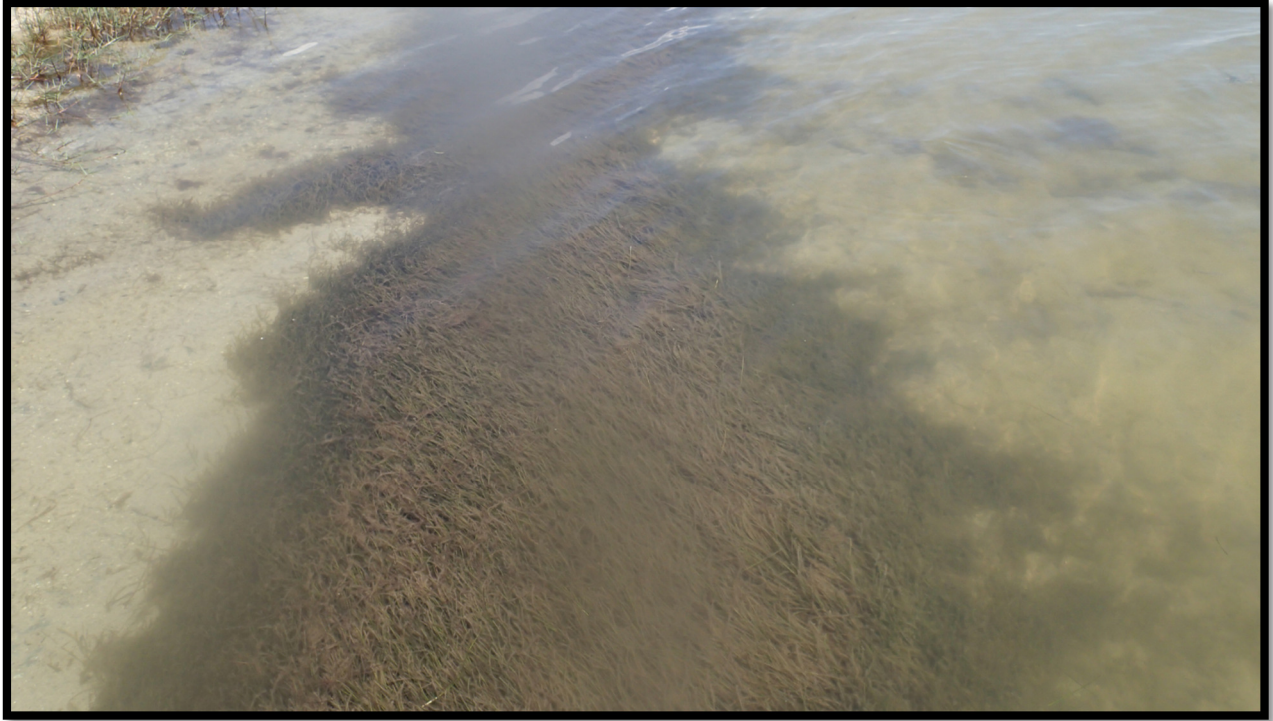
Figure 4. Patchy Seagrass – 9113

**Seagrass, Patchy – 9113** Areas 0.25 acre or greater in size that consist of primarily (greater than 50%) bare bottom in which many small patches (each less than 0.25 acre) of seagrass are scattered, and where the seagrass patches are not interconnected.

Figures 4 and 5 show examples of Patchy Seagrass.

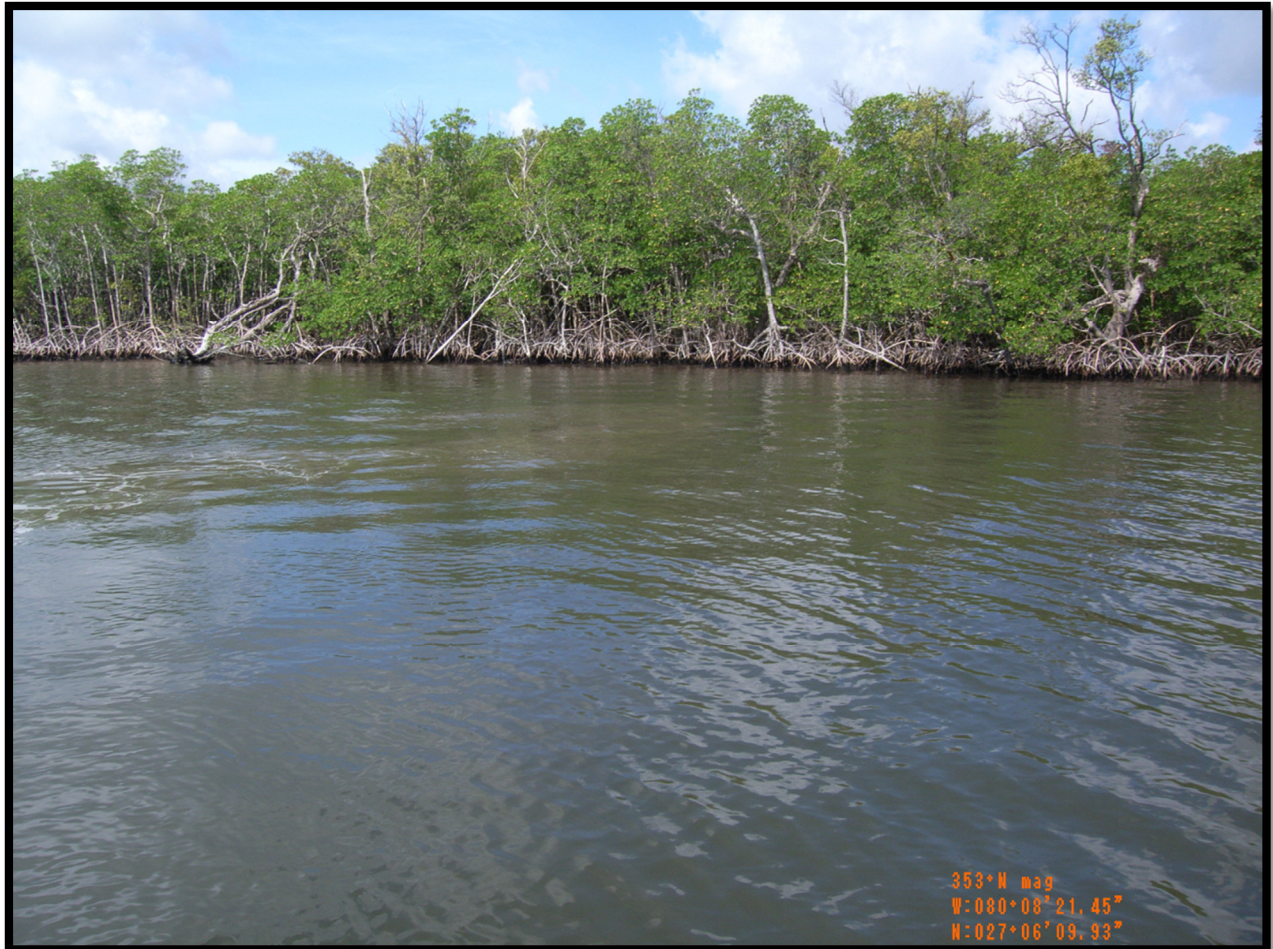
Figure 14. Mangrove hammock – NO SAV

**Not Classified - NO SAV** This classification category includes all covertsypes that are not included within the other covertsype classifications. Examples include the mainland, islands, mangroves, wetland marshes, etc.

Figures 14 and 15 show examples of NO SAV areas.

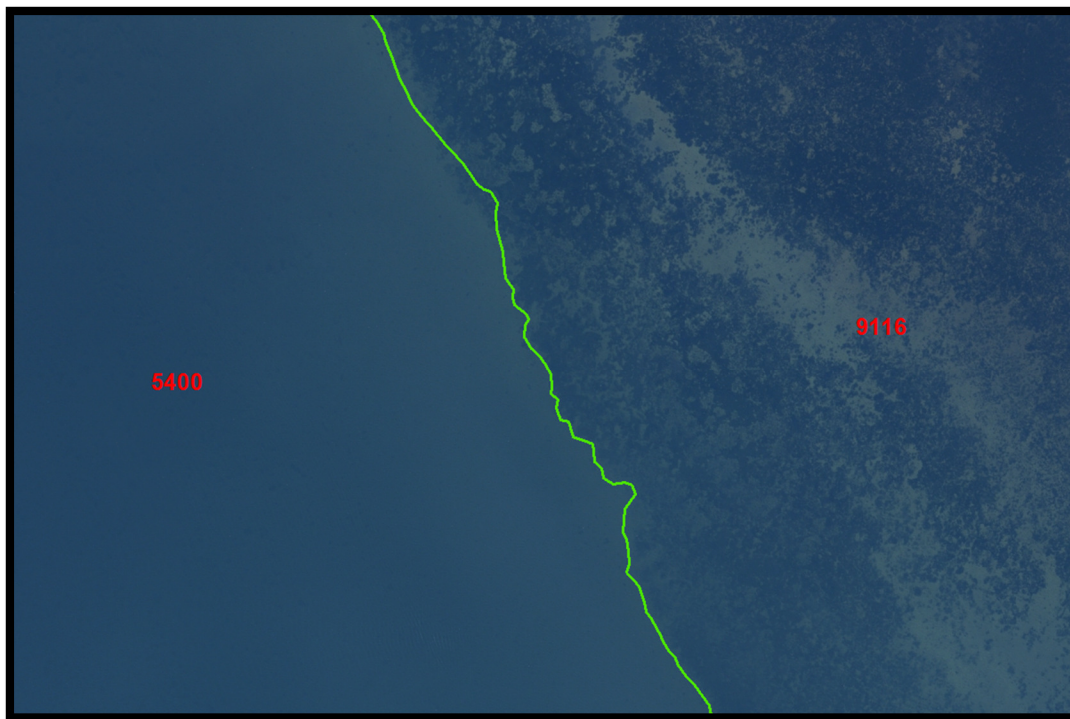
**High Confidence:**

The following figures show examples of delineated aerial photographs that are attributed according to edge confidence.

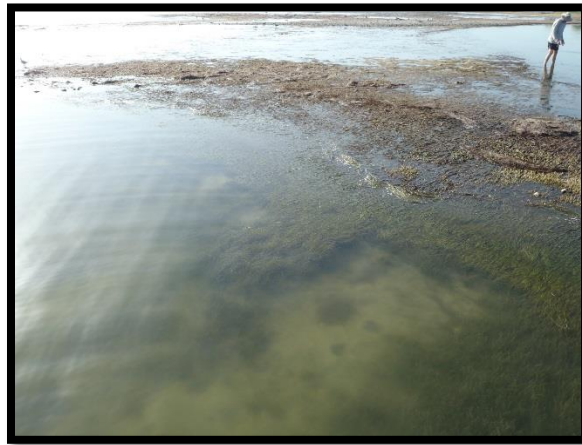
Area around a point location with really shallow and exposed seagrass.

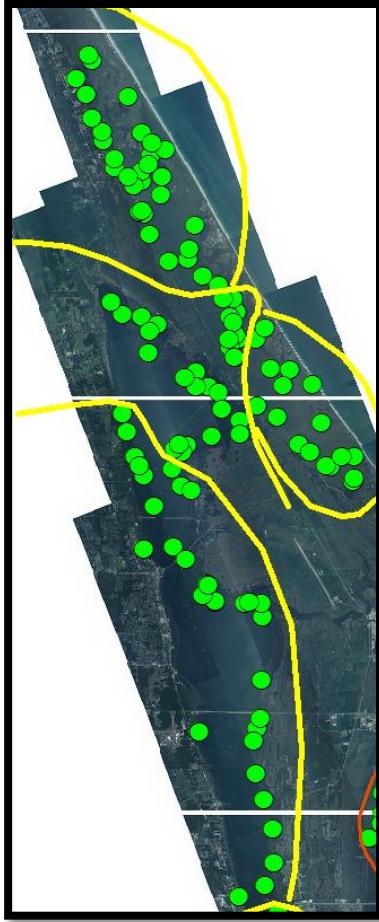
**Location of Trip 2 Field Points. Separate days divided by yellow lines.**

The second Accuracy Assessment trip (July 6<sup>th</sup>-9<sup>th</sup>) encompassed every point north of the Martin Andersen Beachline Expy in the Indian River, as well as all points located in Mosquito Lagoon. There were a total of 112 accuracy points assessed and documented in the ArcMap feature class.

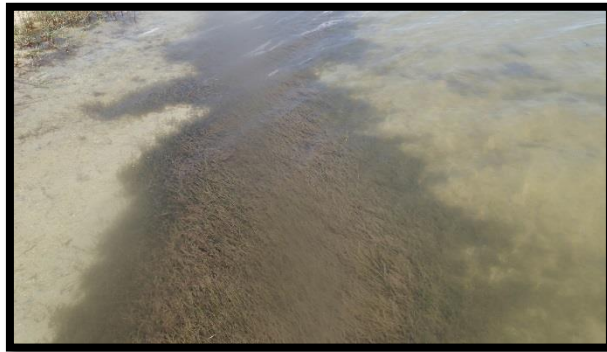
*Band of Halodule wrightii covered in algae located along NASA Causeway.*

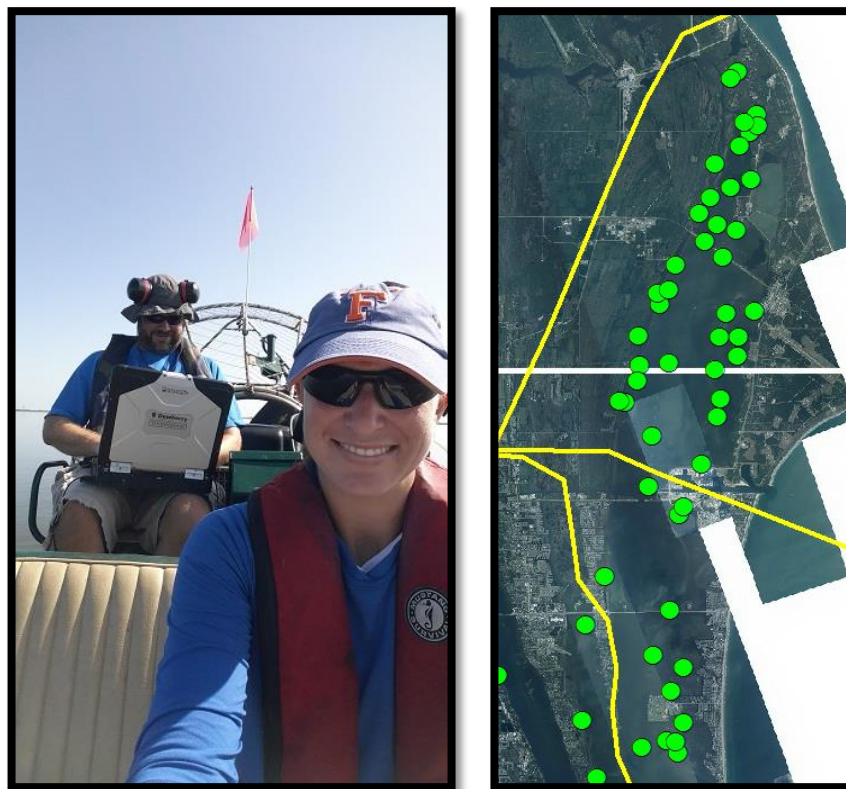
The third and final Accuracy Assessment trip (August 4<sup>th</sup>-5<sup>th</sup>) covered all points remaining in the Banana River, from the tip of Merritt Island up to the northernmost point in the NASA restricted zone. There were a total of 49 accuracy points assessed and documented in the ArcMap feature class.

**Left: Dan and Mel from Dewberry conducting Accuracy Assessment from the KSC airboat.  
Right: Location of Trip 3 Field Points. Separate days divided by yellow lines.**
